Geo-Environmental Assessment

Clitheroe Road, Whalley

Presented to Trafford Housing Trust

Delta-Simons Project No. 18-0886.03

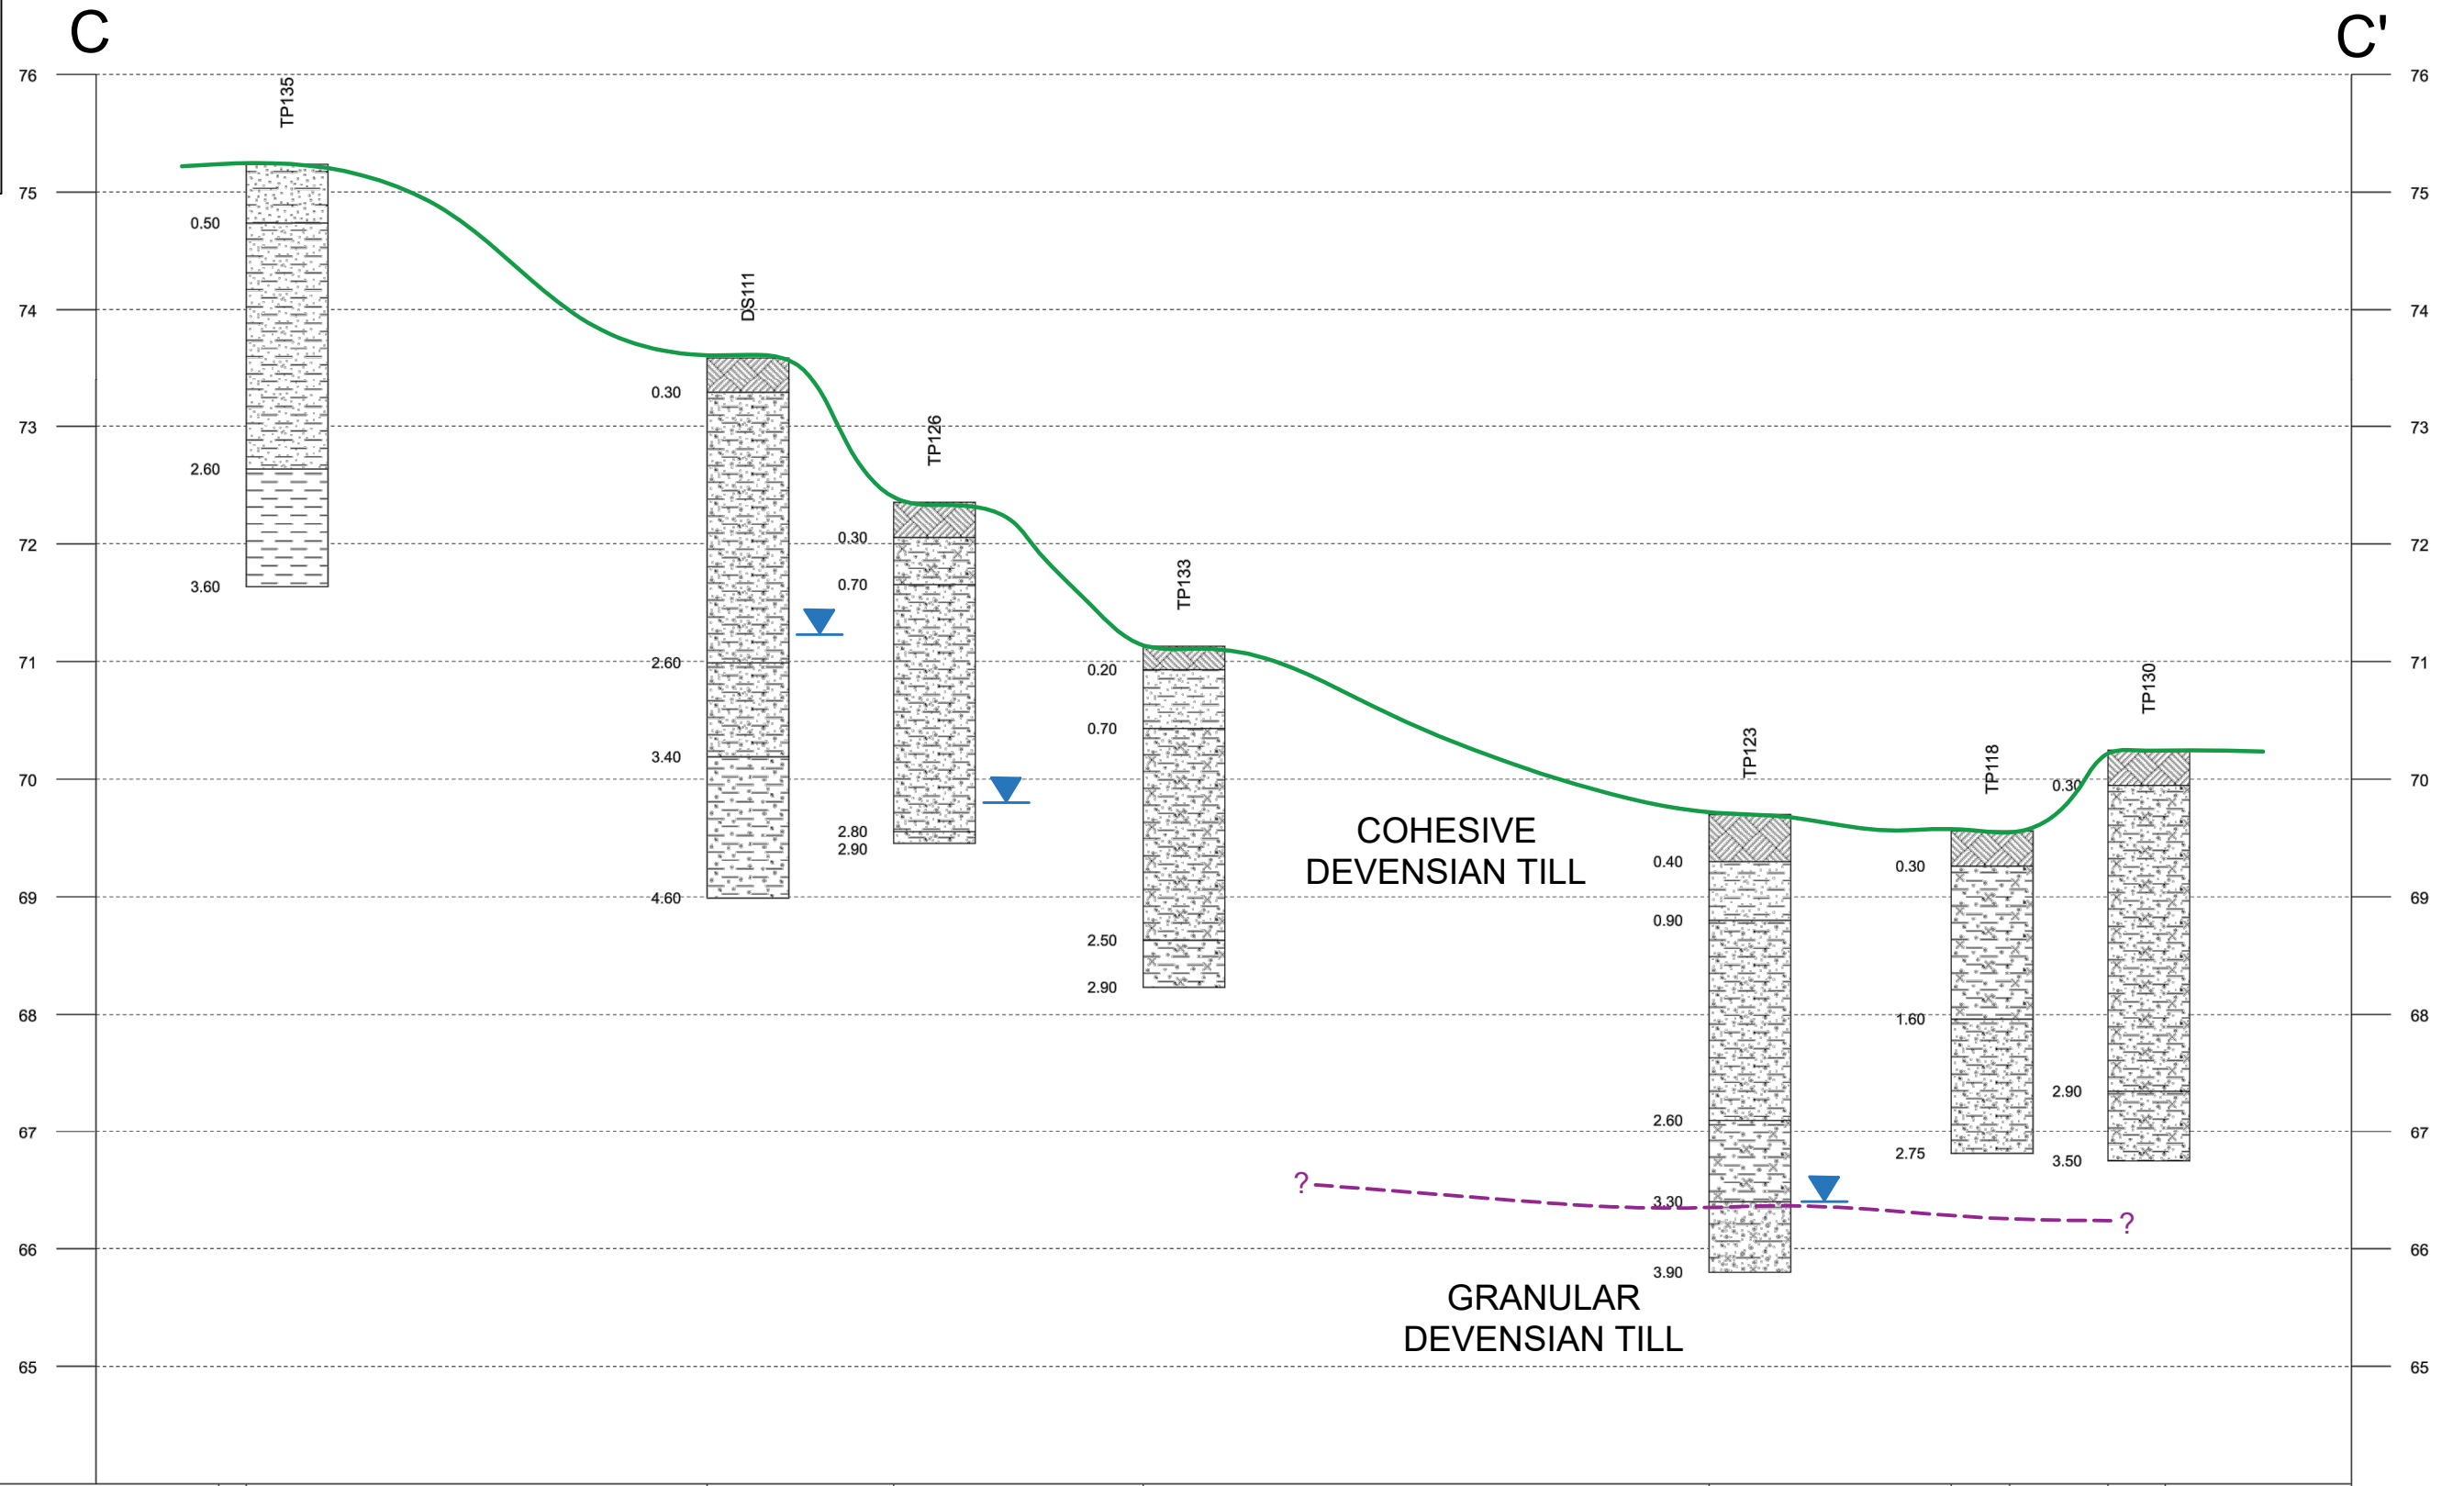
Inferred Geological Cross Sections are presented as Figures 4a, 4b and 4c to provide an appreciation of the ground conditions at the Site and the variations observed within the Devensian Till.

- Clayey SAND
- Sandy CLAY
- TOPSOIL
- Sandy gravelly CLAY
- CLAY
- Silty sandy gravelly CLAY
- Gravelly CLAY
- Silty gravelly CLAY
- Clayey silty sandy GRAVEL

Chainage (m)	0.00	2.93	51.98	71.83	98.38	158.59	184.37	190.59	201.05	207.14
Offset (m)		11.52	3.60	11.38	8.42	9.63	4.45	2.76	7.15	
Elevation (mAOD)	75.24		73.59	72.35	71.13	69.70	69.56	69.68	70.25
